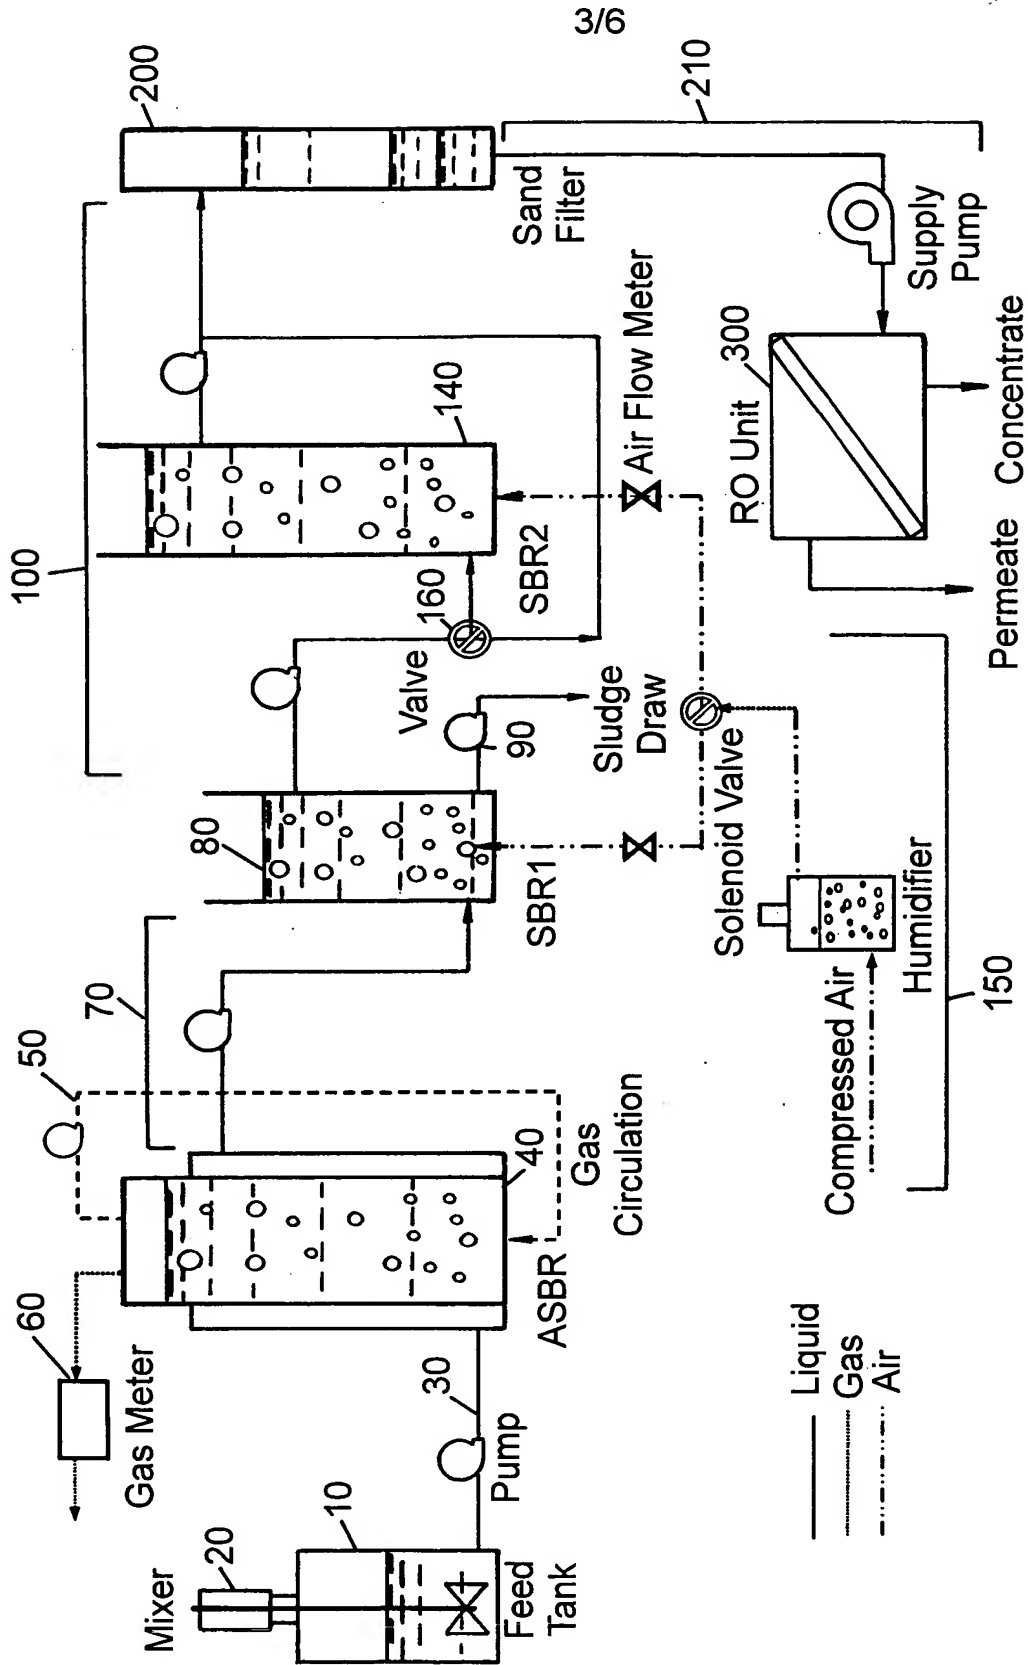
Figure 3 Schematic of laboratory wastewater treatment system.

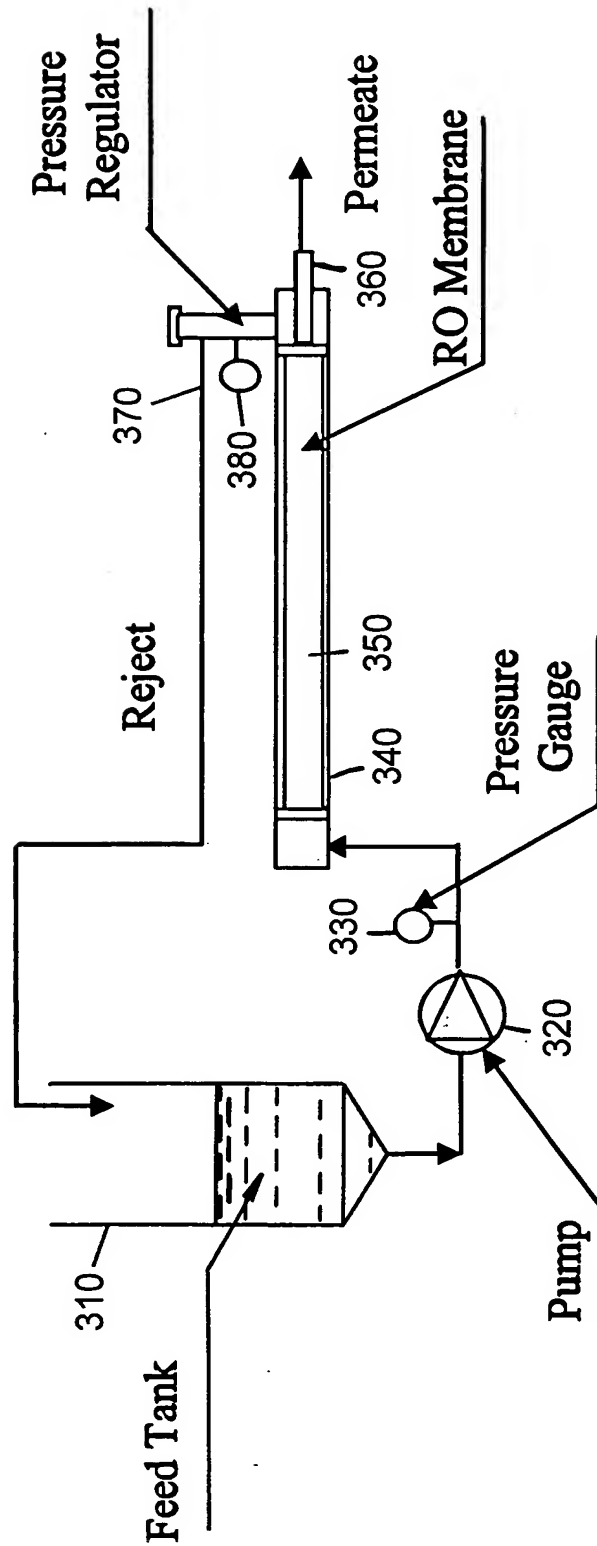
Figure 4 . Schematic of the RO membrane separation test unit.

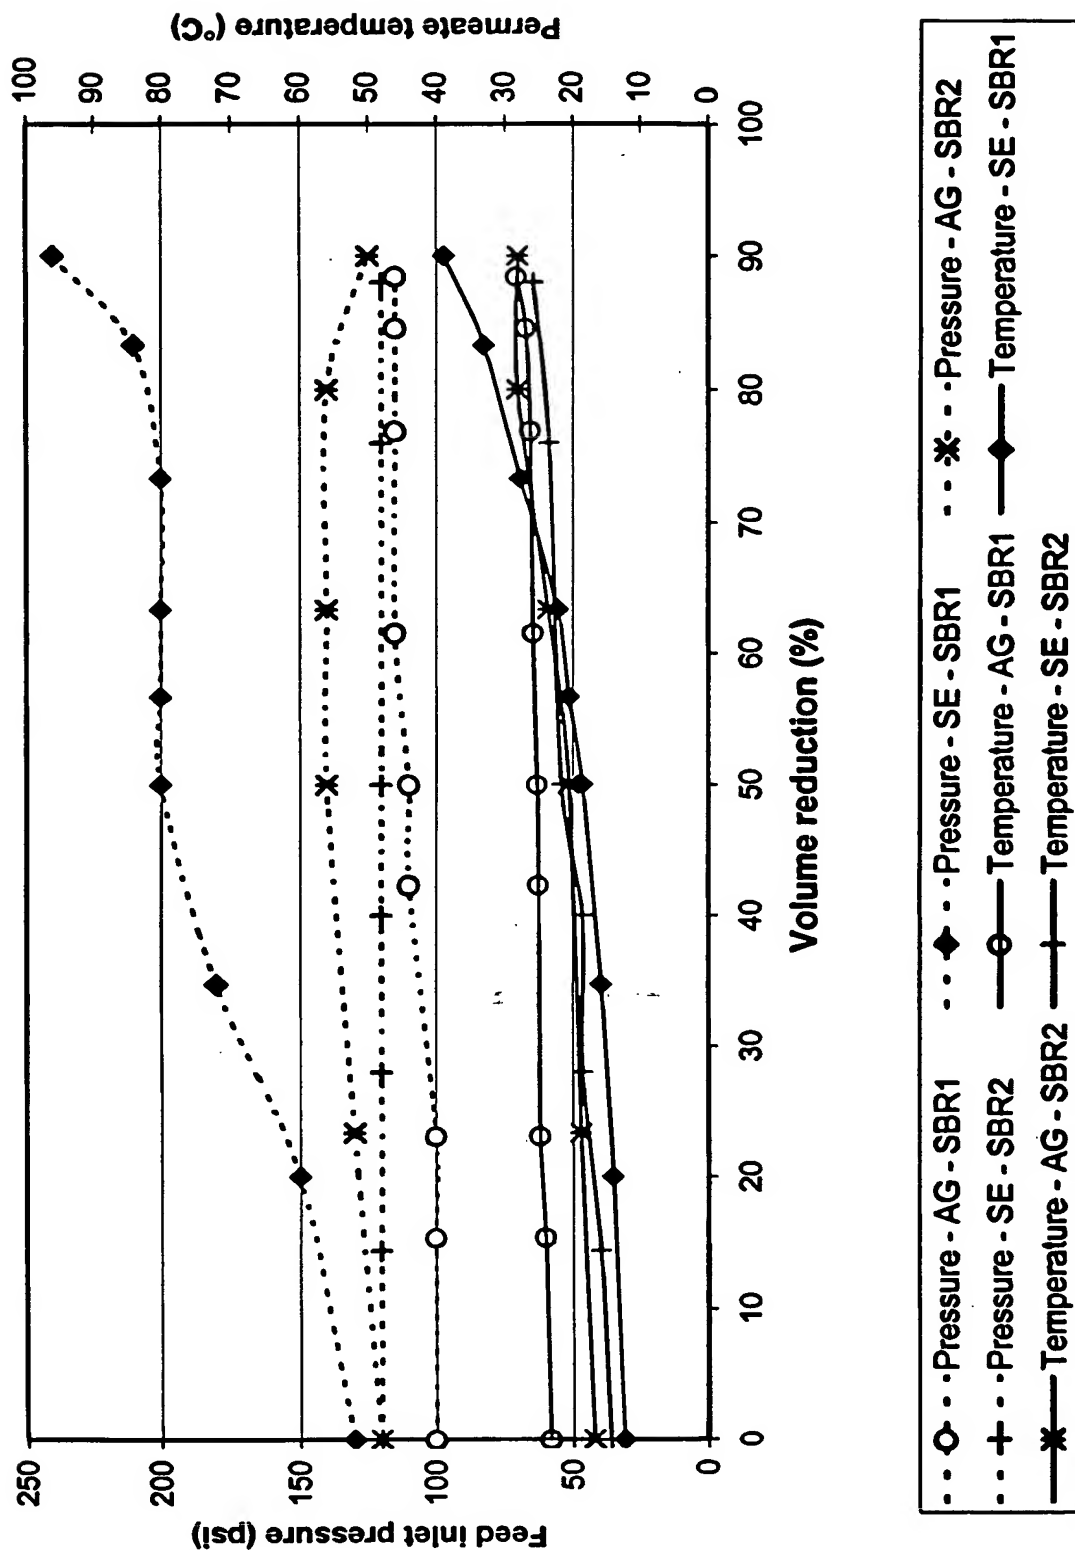
Figure 5. Feed inlet pressure and permeate temperature at different volume reductions

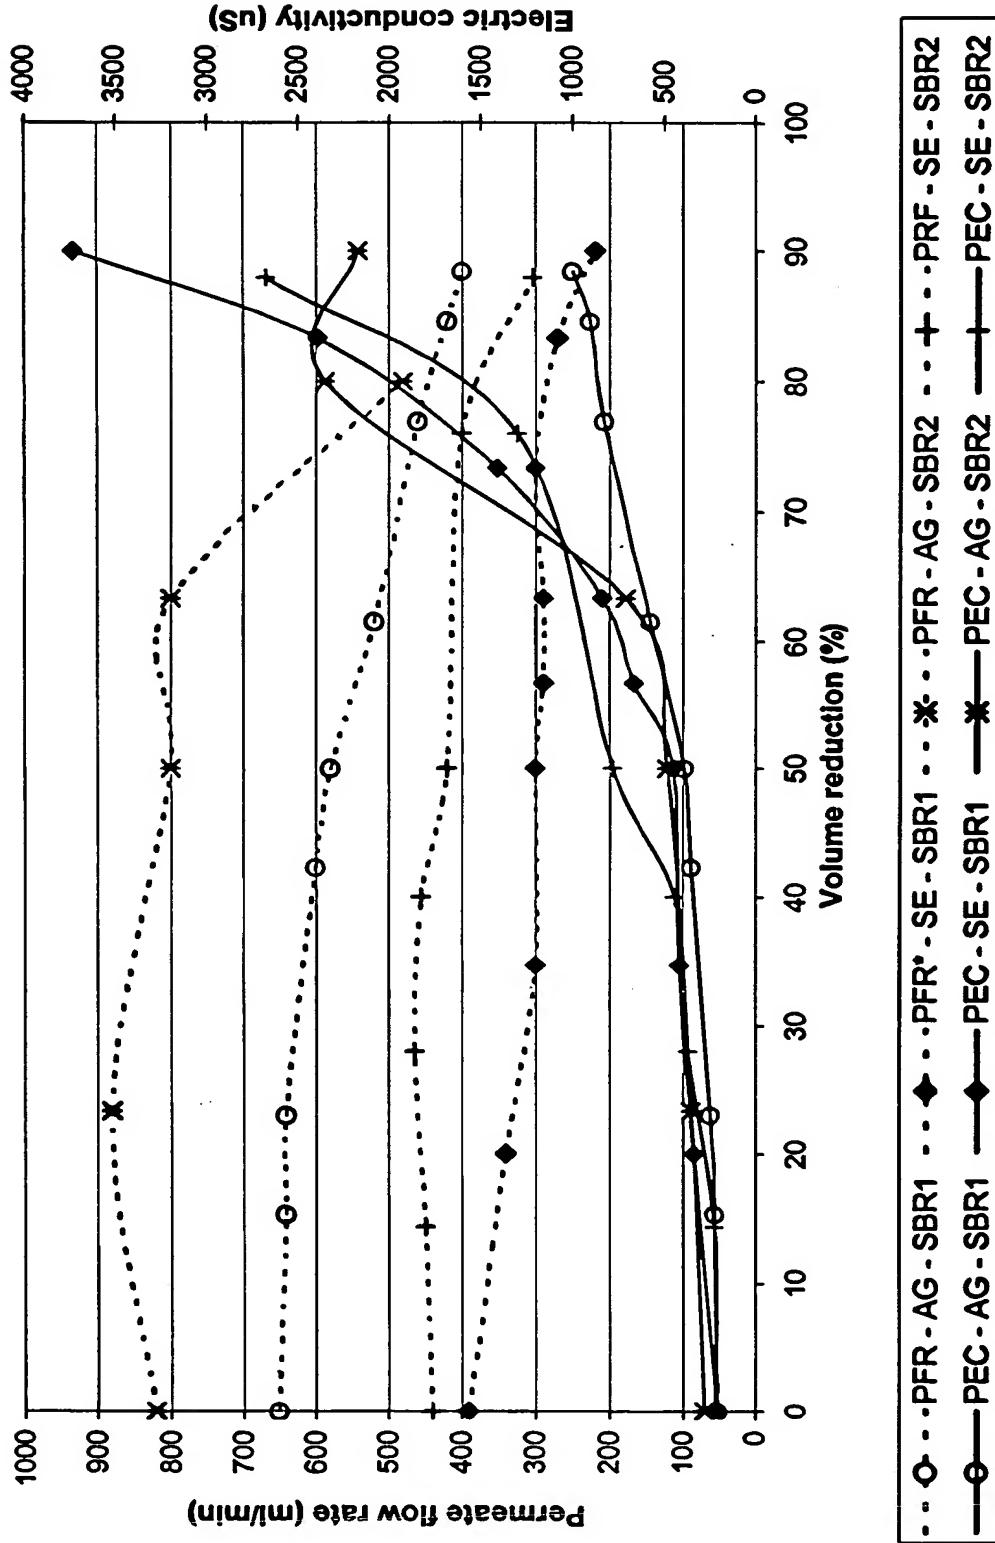
Figure 6. Permeate flow rate and electric conductivity at different volume reductions (PFR -- permeate flow rate, PEC -- permeate electric conductivity, AG -- AG2540, SE -- SE2540)

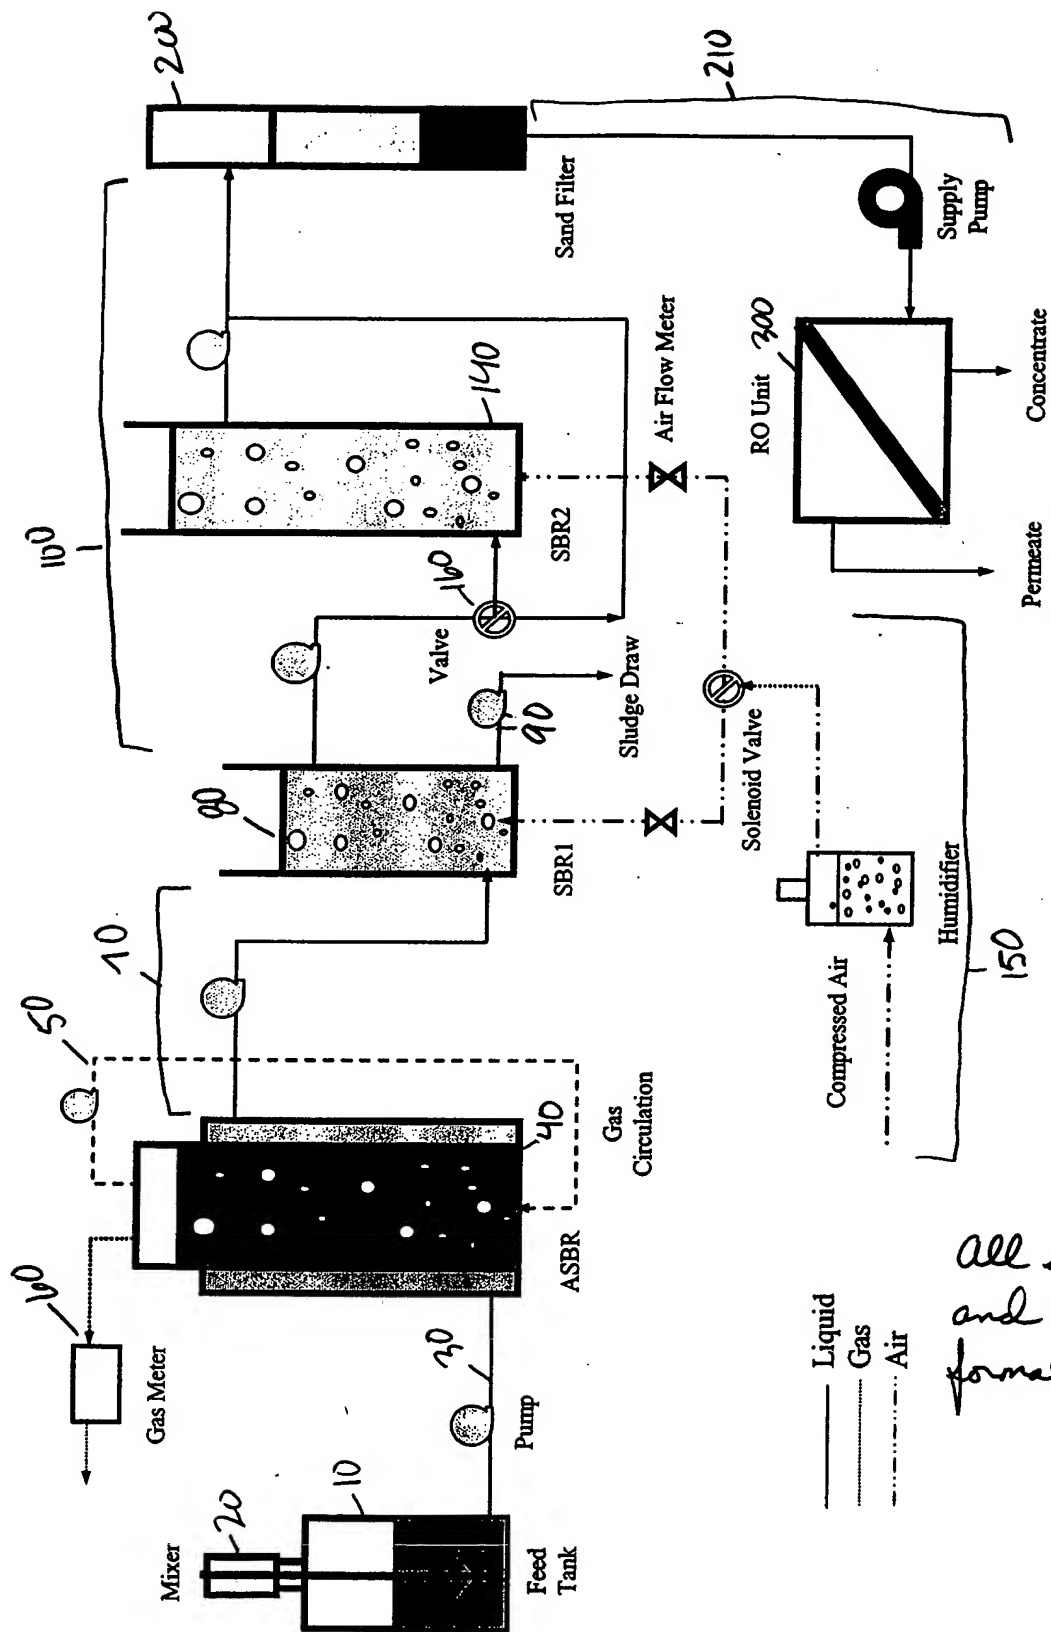
FIGURE 3

Schematic of laboratory wastewater treatment system.

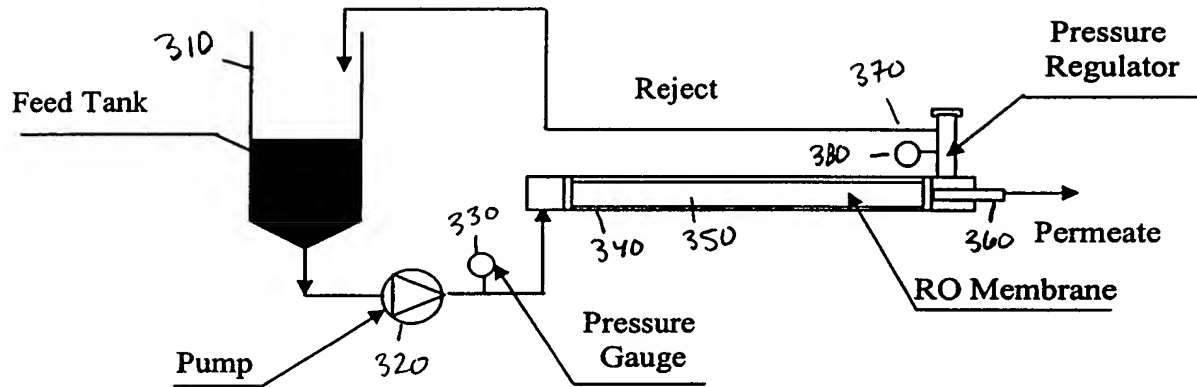
Figure 4 . Schematic of the RO membrane separation test unit.

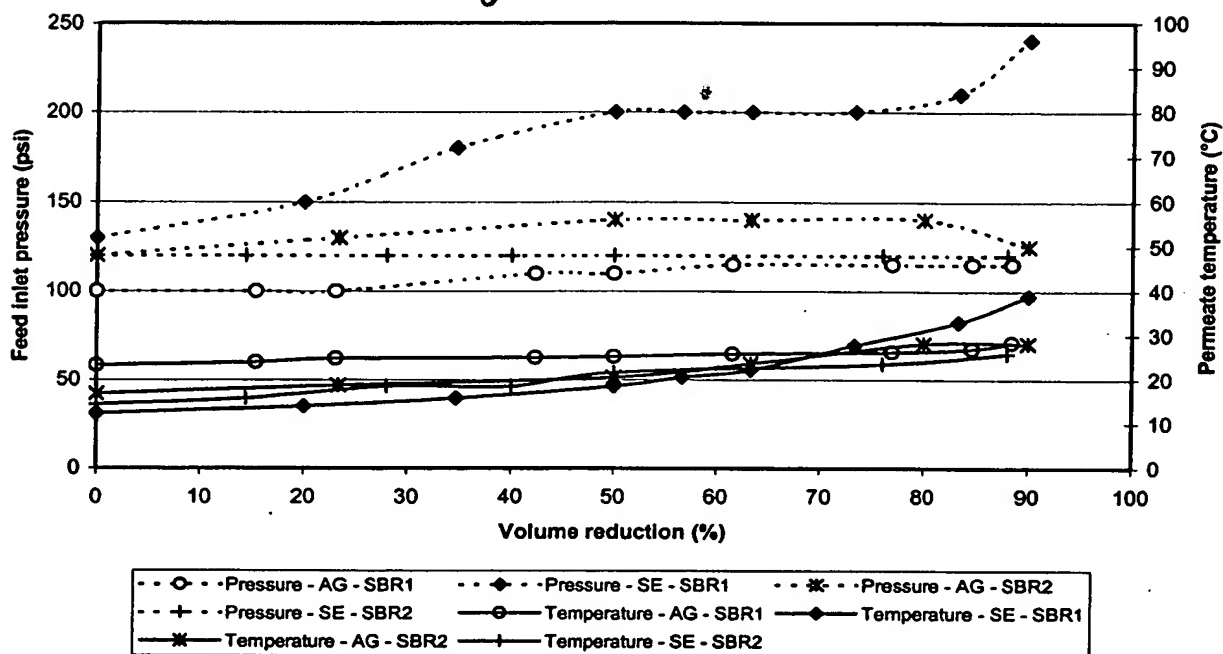
Figure 5. Feed inlet pressure and permeate temperature at different volume reductions

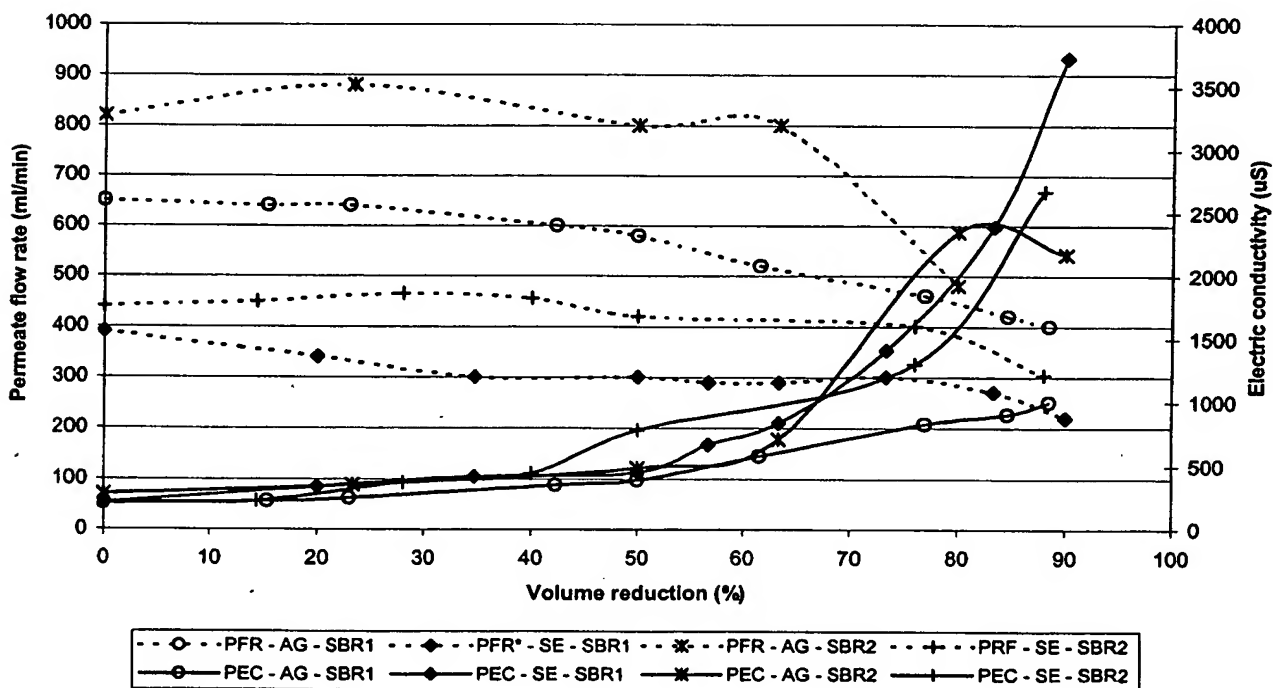
Figure 6. Permeate flow rate and electric conductivity at different volume reductions (PFR - permeate flow rate, PEC - permeate electric conductivity, AG - AG2540, SE - SE2540)
